National  
Defence

FALL 2002

# Flight

# Comment

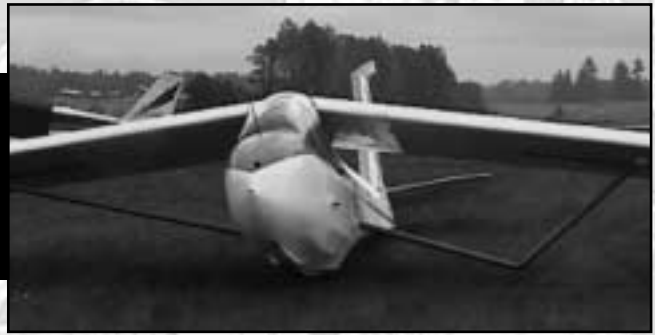
The pilot unstrapped and egressed unhurt. The passenger complained of a sore back. After a local ambulance arrived on scene, the passenger was placed on a backboard and transported to hospital. The passenger was released from hospital later that day. The glider suffered extensive damage to its wings and internal structures.

The investigation revealed that due to task overload, the pilot failed to properly correct for a slightly higher than ideal altitude abeam the landing area by employing three separate yet concurrent altitude correction methods. These corrections placed the glider beyond the point of being able to land at the intended area.

The performance of the pilot was impeded by fatigue related to inadequate rest and nutrition before assuming her duties.

The investigation recommended that clear and effective crew rest orders be inserted into the A-CR-CCP-242/PT-005. ♦

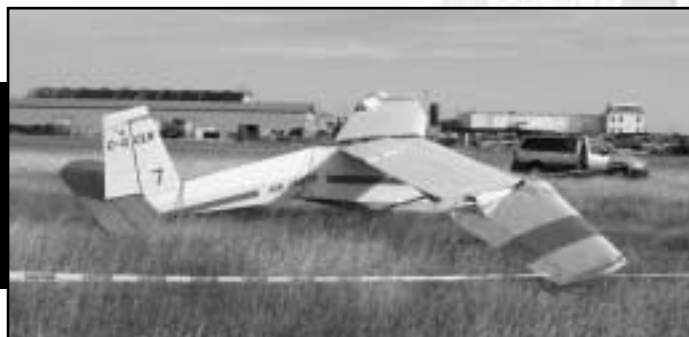
when it impacted the ground. The pilot was the sole occupant and received minor injuries.

The aircraft received A Category damage. Both wingtips contacted the ground, the right wing broke in two at the inboard end of the aileron and the underside of the nose cone was pushed inward. The left wing rear spar attachment point sheared and allowed the wing to rotate forward causing damage to the canopy frame and to the skylight. The rear fuselage bent at the midpoint and the tail wheel broke-off.

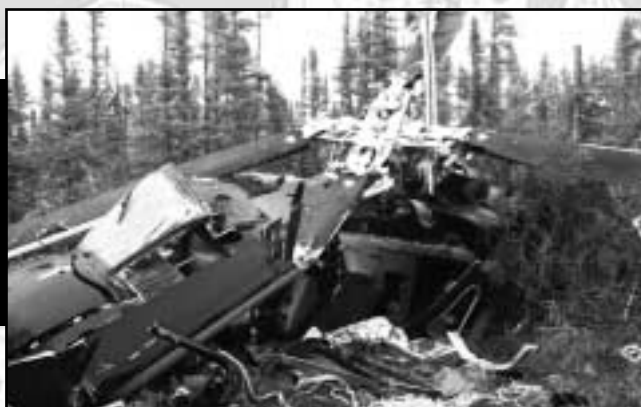
The main tail rotor section was found 280 meters up track from the crash site with one complete tail rotor blade attached while the other blade was missing the outboard 18.5 inches. The 18.5-inch section had fragmented into one large piece and two smaller pieces that were found a further 100 meters up track. Examination and analysis of the tail rotor pieces by QETE identified the tail rotor had failed due to fatigue. Further, the initiation site for the fatigue failure was a 0.008-inch dent or nick that exceeded the 0.003-inch tolerance identified in the maintenance manual common to all Bell 412 operators. It is unknown at this time whether the dent existed before the last maintenance inspection.

Preventative measures taken to date include Special Inspections (SIs) on the tail rotor blades for all CH146s, changes to CH146 tail rotor inspection methods and frequency, daily download of CH146 HUMS (Health Usage and Monitoring System) data, aircrew and ground crew briefings on CH146 airworthiness aspects of the tail rotor and aircrew briefings on emergency procedures. All tail rotor blades on the CH146 Griffon fleet had to successfully pass the SIs in order to be declared serviceable for flying operations. Finally, the Director of Technical Airworthiness (DTA) and DFS will continue to liaise with outside agencies that are concerned with the safe operations of Bell 412 type aircraft, such as Transport Canada Civil Aviation and the American Federal Aviation Authority. Since the aircraft is made entirely of composite material, repairing it is not expected to be economical.

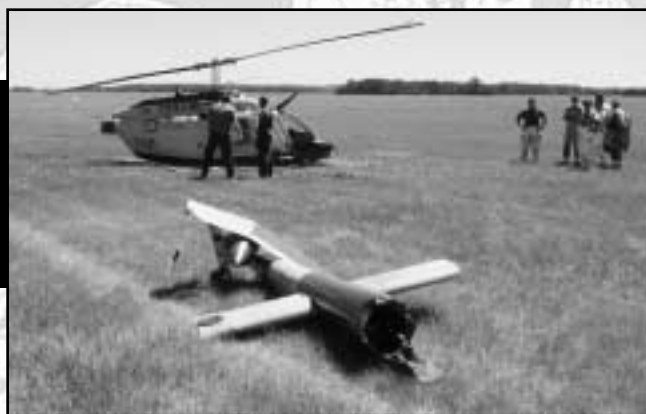
relatively level attitude. The skid gear collapsed resulting in belly contact with the ground. The tail boom was severed at the attachment point to the fuselage. As the tail boom departed the aircraft, the vertical fin was cut by the main rotor blades in two places. The helicopter became airborne again due to impact forces and the collective and throttle position the Standards Officer had initiated for the overshoot. With the loss of the tail rotor, the aircraft rotated through several revolutions due to the main rotor torque. The Standards Officer closed the throttle to minimize the spinning and the helicopter came to rest in an upright position facing the original direction of flight. The crew shut down the aircraft and were evacuated by rescue personnel.

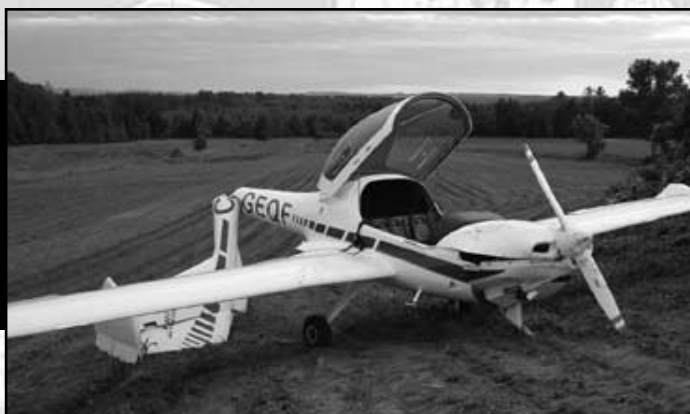
The aircraft received A Category damage. The rear fuselage separated midway between the tail and the cockpit and the right wing was pushed up, damaging the spar and control rods. The nose gear separated and the engine was pushed up, damaging the engine mount and causing a sudden engine stoppage. Since the aircraft is made entirely of composite material, repairing it is not expected to be economical.

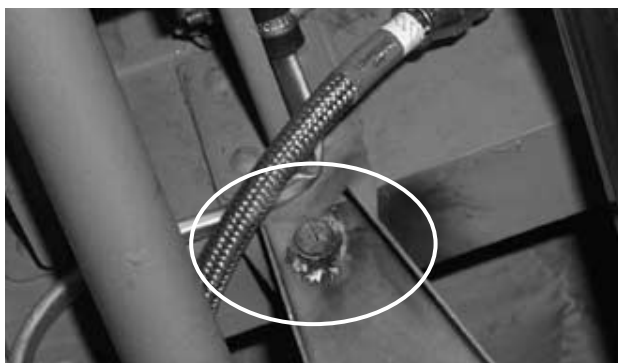
Smoke in cockpit/electrical failure: During shake out (brief inverted flight to check for loose objects), both inverter fail lights illuminated while under negative "G". Aircraft rolled upright and lights extinguished. Approximately 20 seconds later, arcing noises were heard from the circuit breaker panel followed by smoke in the cockpit. Smoke immediately cleared but was followed by a series of electrical system failures. Checklist procedures were then carried out. Aircraft proceeded to a high key position and landing gear was lowered manually. Forced landing was carried out without further incident.

*Circuit breaker panel mount*

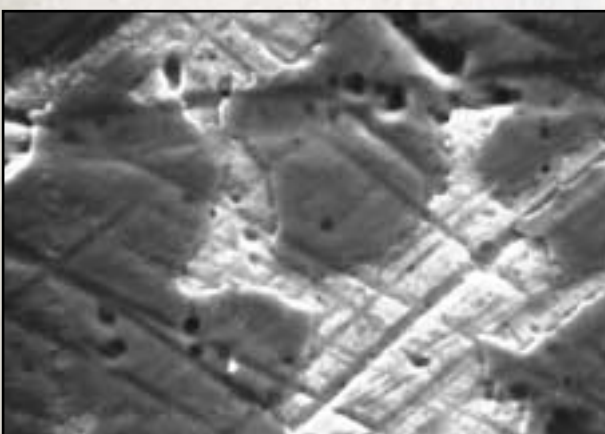
Collective actuator cylinder wall
